**Flood Control Project Maintenance
Levee Inspections**
LMA District Cover Sheet
Spring 2020 Levee Inspection Results

Reclamation District No. 0341 Sherman Island

Waterway			Bank	Unit Miles
Unit No. 01 Threemile Slough			Right	3.36
	Spring (March - May)	Summer (June - August)	(September - November) Fall	Winter (December - February)
Unit Maintenance Rating (Fall Only)				
Date of Inspection	3/25/2020 - 3/25/2020			
DWR Inspector	David Julian			
Accompanied By	Joel McElroy Reclamation District 341

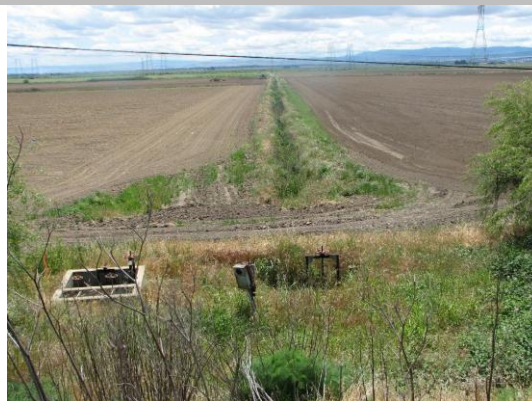
Photo 3 of 3 : UCIP_SP_2020_22259_37934.jpg

Gate located at the toe of the levee on landward side.

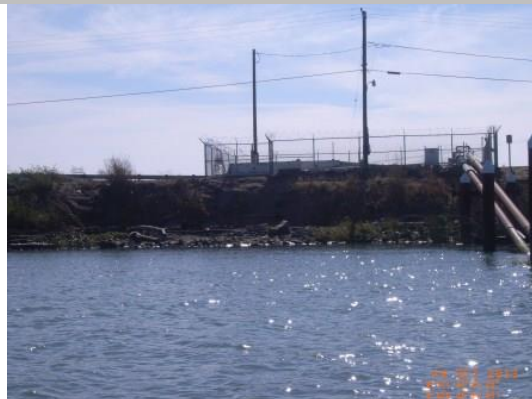
Photo 1 of 1 : SP_2020_RD0341_168_32_20200304_00001.jpg

LM Start	6.03	Rating **	U	Issue No.	32
LM End	6.16	Issue Type +	Ma	Location *	WS
Category	Supplemental			GPS Latitude/Longitude	
				Start	End
Item	2017 USACE Erosion Survey			38.080370 °	38.080526 °
				-121.728341 °	-121.730483 °
DWR ID	DWR_RD0341_02_f_2018_32				
Comment Code					
Inspector Comment					
2017 Site ID: SAC 7.3 L					
Status: Critical					
2017 Field Notes: No observed change..					
Site History: 2011 - Large slump at downstream end. Gully formed from surface runoff from the road. Shallow slumping throughout site.					
2012 - The gully at upstream end has increased in size and site continues to worsen.

USACE 2013 Photo #1

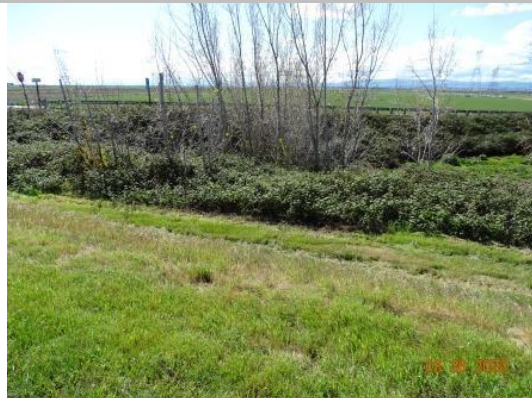
Photo 1 of 1 : SP_2020_RD0341_168_61_20200326_00092.jpg

LM Start	6.17	Rating **	U	Issue No.	61
LM End	6.17	Issue Type +	Ma	Location *	LS
Category	Earthen Levee			GPS Latitude/Longitude	
				Start	End
Item	Vegetation			38.080512 °	38.080512 °
				-121.730703 °	-121.730703 °
DWR ID	DWR_RD0341_02_s_2020_61				
Comment Code					
V2 : Remove the wild growth other than native grasses from the levee slopes.					
Inspector Comment					
Thick blackberries on the landside toe.

View of thick blackberries on the landside toe (Spring 2020).

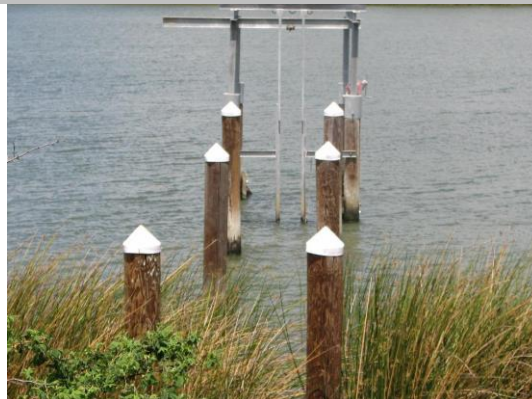
Photo 1 of 3 : UCIP_SP_2020_39861_71853.jpg

DS_ID:24076
FS_ID:39861
EP_NO: 11116
Repair Type: Non-Urgent
Crossing Status: Found
UCIP Comments: Need to contact owner to determine status of crossing. If crossing is no longer used will need to meet Title 23 requirements. Hole present in pipe section. Debris on waterward side--10-inch pipe section abandoned on slope. Dense vegetation limits the inspector's visibility to identify signs of pipe failure (leaks) along the slope. Recommend removing vegetation along pipe alignment to conduct proper inspection of structure and appurtenances.
FIELD_STRUCT_DESC: 12-inch steel irrigation pipe sleeved through 14-inch pipe through levee, 4.0 feet below crown. Annular gap grouted. Slide gate in distribution box on landside (LS). (12-inch sleeved through 14-inch pipe authorized under Automatic Board Order (ABO) issued as Permit No. 11116, 1975 - C. E. & J. E. Upham; widen and realign State HWY 160 and extend three irrigation pipes authorized under Permit No. 15372, 1993 - Department of Transportation [Caltrans]) [Additional Reference(s): DWR Levee Log, 1992. USACE Sacramento O&M Manual Unit No. 101, February 1962, (HLM 6.12). LMA encroachment station (STA) reference based on Map of Evacuation Route, Reclamation District 341 Sherman Island by Wagner Bonsignore Consulting Civil Engineers, A Corporation dated July 2012, STA 874+00]

View of structure located on waterward side.

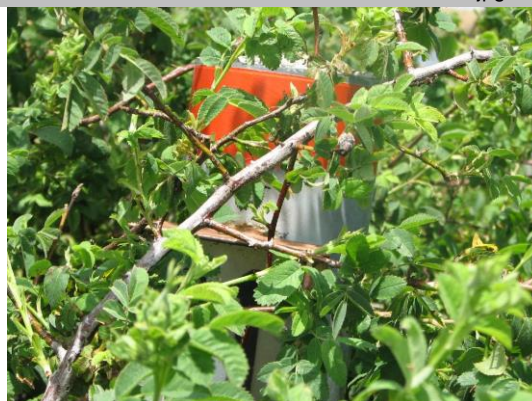
Photo 2 of 3 : UCIP_SP_2020_39861_71852.jpg

Marker visible on waterward side associated with crossing.

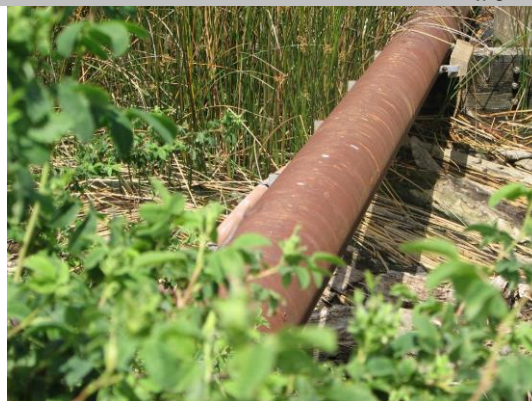
Photo 3 of 3 : UCIP_SP_2020_39861_71851.jpg

Pipe section visible on waterward side.

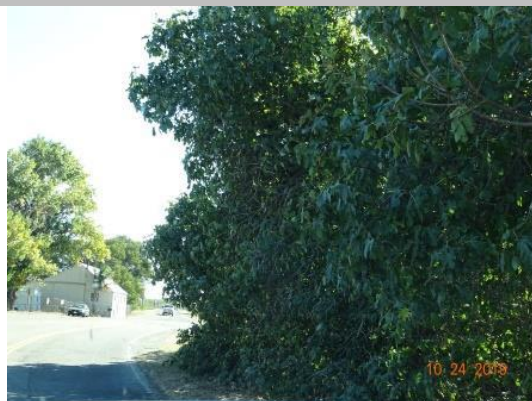
Photo 1 of 1 : SP_2020_RD0341_168_47_20200304_00012.jpg

LM Start	6.30	Rating **	U	Issue No.	47
LM End	6.30	Issue Type +	En	Location *	LS
Category	Earthen Levee			GPS Latitude/Longitude	
				Start	End
Item	Vegetation			38.081073 °	38.081073 °
				-121.733038 °	-121.733038 °
DWR ID	DWR_RD0341_02_f_2015_47				
Comment Code					
V6 : Landscaping					
Inspector Comment					
Remove the Fig trees or trim them up five foot from the ground so the levee slope can be inspected.

View looking upstream at fig tree on the landside slope (Fall 2019).

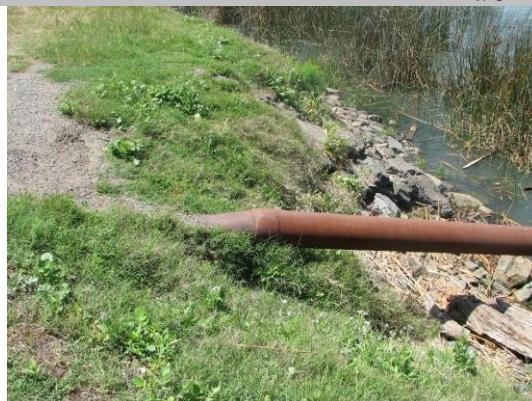
Photo 1 of 3 : UCIP_SP_2020_22261_37949.jpg

DS_ID:24078
FS_ID:22261
EP_NO: 11116
Repair Type: Non-Urgent
Crossing Status: Found
UCIP Comments: Dense vegetation limits the inspector's visibility to identify signs of pipe failure (leaks) along the slope. Recommend removing vegetation along pipe alignment to conduct proper inspection of structure and appurtenances.
FIELD_STRUCT_DESC: 12-inch steel pipe of unknown purpose through the levee, 2 feet below the crown. Siphon breaker on landside (LS) slope. Rock revetment on waterside (WS) slope. (12-inch authorized under Automatic Board Order (ABO) issued as Permit No. 11116, 1975 - C. E. & J. E. Upham) [Additional Reference(s): DWR Levee Log, 1992. USACE Sacramento O&M Manual Unit No. 101, February 1962, (HLM 6.30). LMA encroachment station (STA) reference based on Map of Evacuation Route, Reclamation District 341 Sherman Island by Wagner Bonsignore Consulting Civil Engineers, A Corporation dated July 2012, STA 857+00]

Side view of pipe on waterward side.

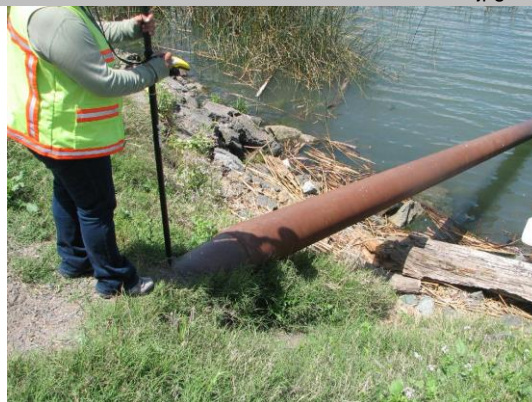
Photo 2 of 3 : UCIP_SP_2020_22261_37947.jpg

View of pipe and rip rap on waterward side.

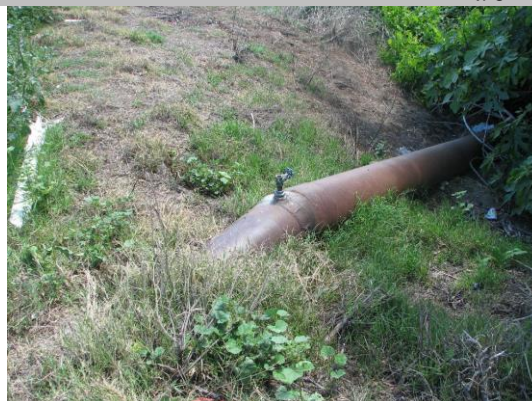
Photo 3 of 3 : UCIP_SP_2020_22261_37948.jpg

View of crossing on landward slope.

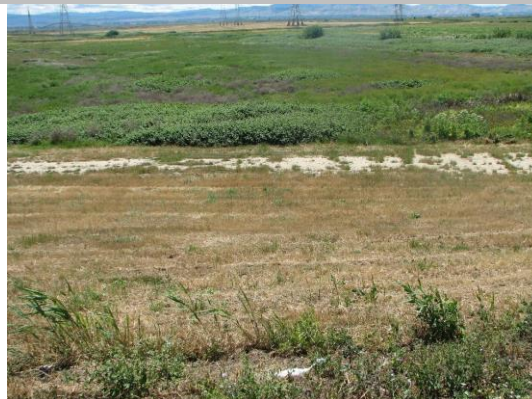
Photo 1 of 2 : UCIP_SP_2020_22262_37953.jpg

DS_ID:24079
FS_ID:22262
EP_NO: 11107
Repair Type: Non-Urgent
Crossing Status: Indicator Found
UCIP Comments: Need to contact owner to determine status of crossing. If crossing is no longer in used owner will need to comply with Title 23. Dense vegetation limits the inspector's visibility to identify signs of pipe failure (leaks) along the slope. Recommend removing vegetation along pipe alignment to conduct proper inspection of structure and appurtenances.
FIELD_STRUCT_DESC: 4-inch steel pipe type unknown through the levee, 4 feet below the crown. (4-inch pipe authorized under Permit No. 11107, 1975 - G. Celli) [Additional Reference(s): DWR Levee Log, 1992. LMA encroachment station (STA) reference based on Map of Evacuation Route, Reclamation District 341 Sherman Island by Wagner Bonsignore Consulting Civil Engineers, A Corporation dated July 2012, STA 851+00]
FS Date: 5/6/2009

View of landward side no evidence of crossing.

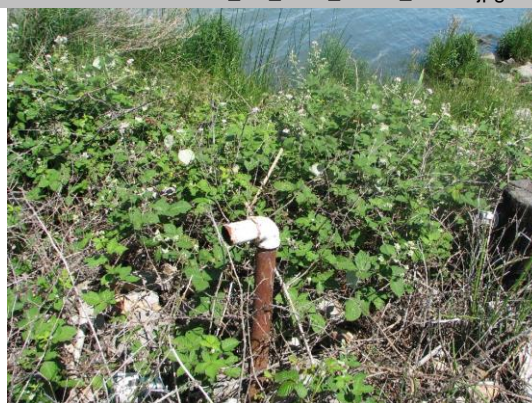
Photo 2 of 2 : UCIP_SP_2020_22262_37952.jpg

View of waterward side air vent pipe could be associated with crossing.

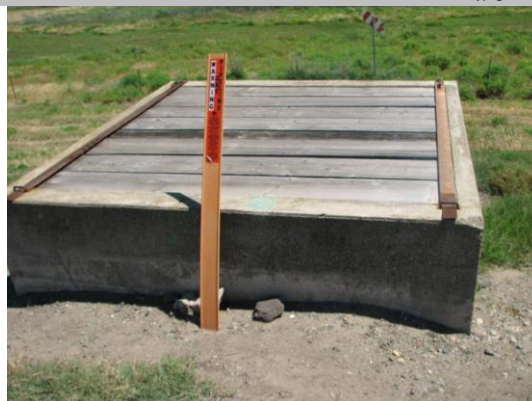
Photo 1 of 3 : UCIP_SP_2020_22263_37962.jpg

Comment Code					
Inspector Comment					
DS_ID:24081 FS_ID:22263 EP_NO: 892 Repair Type: Non-Urgent Crossing Status: Found UCIP Comments: Need to contact owner to determine status of crossing. Need date of last inspection and confirmation that crossing is still in operable condition. FIELD_STRUCT_DESC: 1 of 2: 12.75-inch steel gas line through the levee, 2.0 feet below the crown. Concrete cutoff wall around pipes at center of levee. Location marker on waterside (WS) slope. Concrete control box and valve pit on landside (LS) slope. Utility marker contact information includes Contact prior to Excavation call 1-800-227-2600 or Emergency Contact 1-800-811-4111. (12.75-inch gas line authorized under Permit No. 892, 1942 - Pacific Gas and Electric Company [PG&E]) [Additional Reference(s): DWR Levee Log, 1992. LMA encroachment station (STA) reference based on Map of Evacuation Route, Reclamation District 341 Sherman Island by Wagner Bonsignore Consulting Civil Engineers, A Corporation dated July 2012, STA 826+00] FS Date: 5/6/2009

View of landward side. Concrete box and markers indicating gas pipeline. Additional marker located at levee toe.

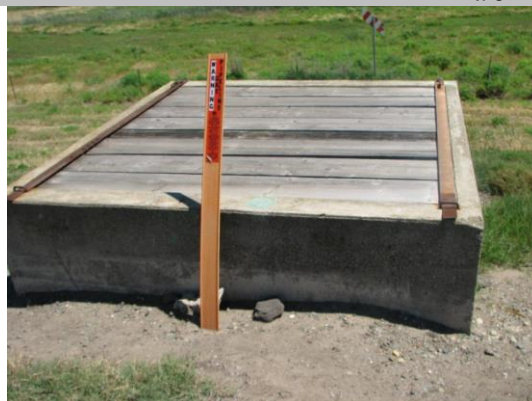
Photo 1 of 3 : UCIP_SP_2020_22264_37965.jpg

DS_ID:24234
 FS_ID:22264
 EP_NO: 892
 Repair Type: Non-Urgent
 Crossing Status: Found
 UCIP Comments: Need to contact owner to determine status of crossing. Need date of last inspection and confirmation that crossing is still in operable condition.
 FIELD_STRUCT_DESC: 2 of 2: 12.75-inch steel gas line through the levee, 2.0 feet below the crown. Concrete cutoff wall around pipes at center of levee. Location marker on waterside (WS) slope. Concrete control box and valve pit on landside (LS) slope. Utility marker contact information includes Contact prior to Excavation call 1-800-227-2600 or Emergency Contact 1-800-811-4111. (12.75-inch gas line authorized under Permit No. 892, 1942 - Pacific Gas and Electric Company [PG&E]) [Additional Reference(s): DWR Levee Log, 1992. LMA encroachment station (STA) reference based on Map of Evacuation Route, Reclamation District 341 Sherman Island by Wagner Bonsignore Consulting Civil Engineers, A Corporation dated July 2012, STA 826+00]

Concrete box and marker located on near landward shoulder. Additional marker located at the levee toe.

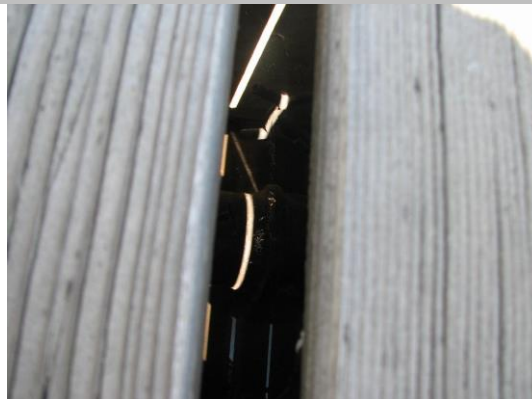
Photo 2 of 3 : UCIP_SP_2020_22264_37964.jpg

Unable to confirm the number of pipe through section of levee.

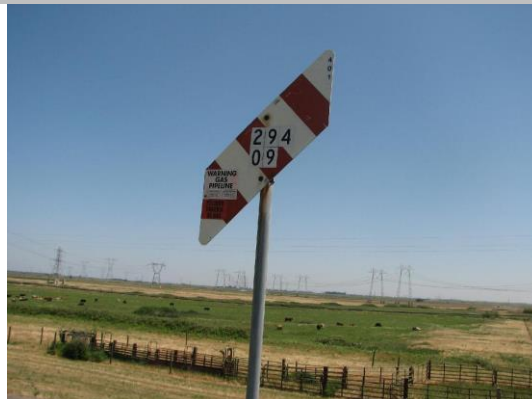
Photo 1 of 2 : UCIP_SP_2020_22267_37978.jpg

DS_ID:24193
FS_ID:22267
EP_NO: 15777
Repair Type: Non-Urgent
Crossing Status: Indicator Found
UCIP Comments: Need to contact owner to determine status of crossing. Need date of last inspection and confirmation that crossing is still in operable condition. Multiple crossings in general area need to clarify which pipes are in this levee section.
FIELD_STRUCT_DESC: 42-inch steel natural gas line through the levee, bored 30-feet below the channel and both levees. Utility marker contact information includes Contact prior to Excavation call 1-800-227-2600 or Emergency Contact 1-800-811-4111. (42-inch line authorized under authorized Permit No. 15777, 1993 - PGT - PG&E Pipeline Expansion Project) [Additional Reference(s): LMA encroachment station (STA) reference based on Map of Evacuation Route, Reclamation District 341 Sherman Island by Wagner Bonsignore Consulting Civil Engineers, A Corporation dated July 2012, STA 826+00]

Marker located on landward side.

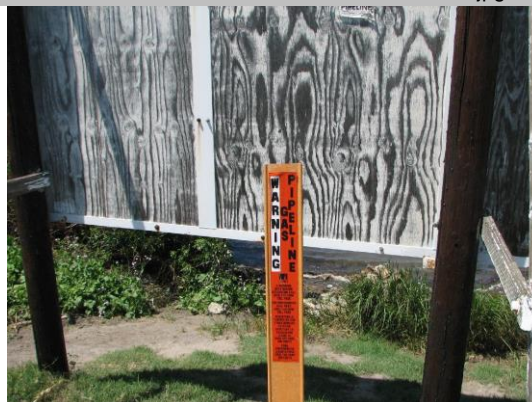
Photo 2 of 2 : UCIP_SP_2020_22267_37977.jpg

Marker located on waterward side.

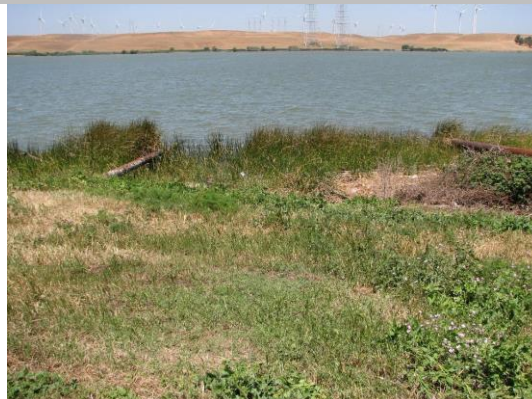
Photo 1 of 3 : UCIP_SP_2020_22293_38041.jpg

DS_ID:24128
FS_ID:22293
EP_NO: 1915
Repair Type: Non-Urgent
Crossing Status: Found
UCIP Comments: Will need to contact owner. Need to obtain maintenance records and clarify modifications made at to crossing (size). Also important to note that DWR DOE was out in the field during our pipe inspection they were conducting pipe evaluation for pipe replacement. Need to contact DWR DOE to determine location of pipe replacement.
FIELD_STRUCT_DESC: 18-inch (not 12-inch as noted in historical records) steel irrigation pipe through the levee, 3.0 feet below the crown. 30-inch concrete standpipe riser on landside (LS). (Permit No. 1352-1948) Siphon breaker on landward side installed under Permit No. 1915 (1954). Pipe removed and replaced by 12-inch steel pipe under Permit No. 10799 (1977). (12-inch siphon pipe authorized under Permit No. 1352, 1948 - Celli Brothers; 12-inch pipe and 20-inch pipe approximately 4,900 feet and 9,400 feet downstream (D/S), respectively, from Emmaton authorized under Permit No. 1915, 1954 - Celli Brothers; 12-inch pipe authorized to replace existing 12-inch pipe under Permit No. 10799, 1977 - Gene Celli) [Additional Reference(s): DWR Levee Log, 1992. LMA encroachment station (STA) reference based on Map of Evacuation Route, Reclamation District 341 Sherman Island by Wagner Bonsignore Consulting Civil Engineers, A Corporation dated July 2012, STA 799+00]

Overview of waterward side-18-inch pipe located on right side and 12-inch pipe located on left side.

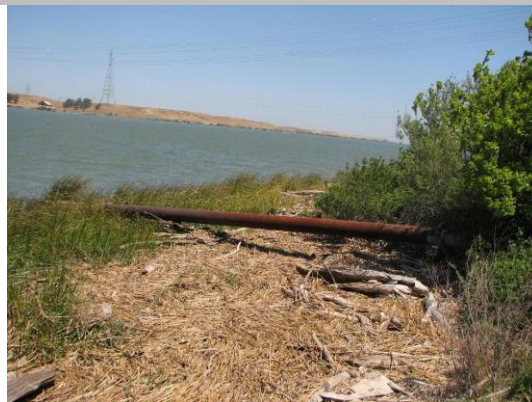
Photo 2 of 3 : UCIP_SP_2020_22293_38040.jpg

View of crossing located on waterward side.

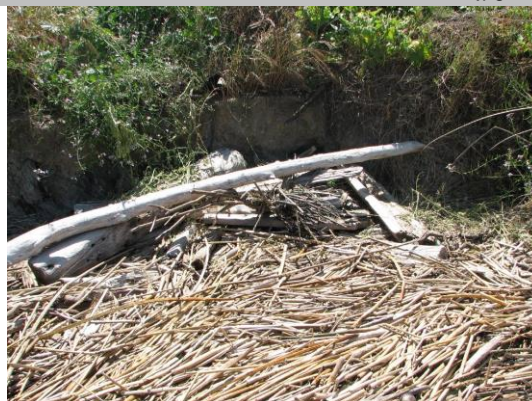
Photo 3 of 3 : UCIP_SP_2020_22293_38044.jpg

Concrete headwall found on waterward side.

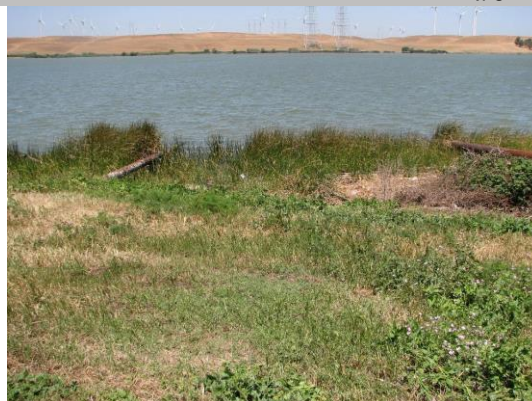
Photo 1 of 3 : UCIP_SP_2020_22294_38046.jpg

DS_ID:24243
FS_ID:22294
EP_NO: 10799
Repair Type: Non-Urgent
Crossing Status: Found
UCIP Comments: Will need to contact owner. Need to obtain maintenance records and clarify modifications made at crossing (size). Also important to note that DWR DOE was out in the field during our pipe inspection they were conducting pipe evaluation for pipe replacement. Need to contact DWR DOE to determine location of pipe replacement.
FIELD_STRUCT_DESC: 12-inch steel irrigation pipe through the levee, 5.3 feet below the crown. Steel cutoff wall around pipe at center of levee. Siphon breaker on landside (LS) shoulder. Steel (not concrete as mentioned in historical records) pipe riser on the LS. 2-inch pipe sleeve around pipe at waterside (WS) shoulder. Rock revetment on WS slope. Pipe exposed along WS slope. (12-inch pipe authorized under Permit No. 10799, 1977 - G. Celli) [Additional Reference(s): DWR Levee Log, 1992. LMA encroachment station (STA) reference based on Map of Evacuation Route, Reclamation District 341 Sherman Island by Wagner Bonsignore Consulting Civil Engineers, A Corporation dated July 2012, STA 799+00]

Overview of waterward side- 12-inch pipe located on left side and 18-inch pipe located on right side.

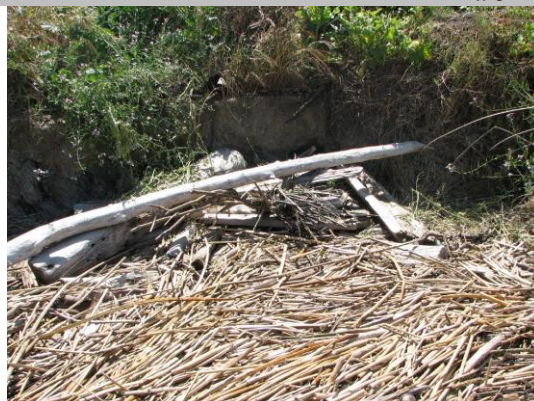
Photo 2 of 3 : UCIP_SP_2020_22294_38050.jpg

Concrete headwall located on waterward side.

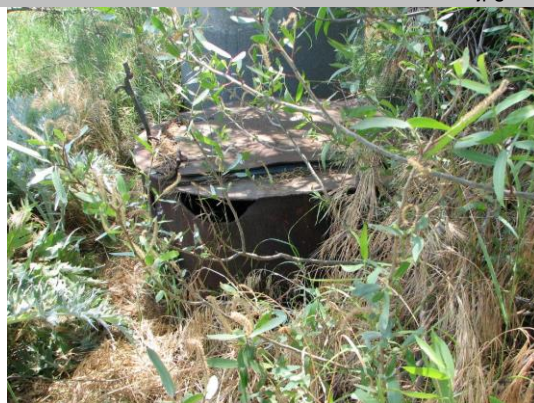
Photo 3 of 3 : UCIP_SP_2020_22294_38047.jpg

Steel stand pipe located on landward side near levee toe.

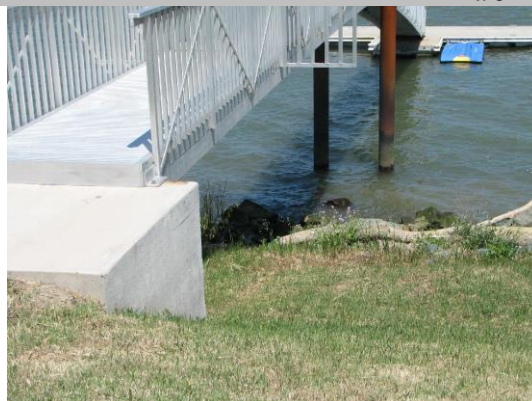
Photo 1 of 3 : UCIP_SP_2020_22303_38062.jpg

Comment Code						
Inspector Comment						
DS_ID:24246						
FS_ID:22303						
EP_NO: N/A						
Repair Type: Non-Urgent						
Crossing Status: Found						
UCIP Comments: Need to determine the status of conduit--has construction been completed?						
FIELD_STRUCT_DESC: Four 2.5-inch conduits sleeved through 12-inch steel pipe through the levee at an unknown depth below the levee crown. Boat launching dock and ramp are located on the waterside (WS). [Additional Reference(s): LMA encroachment station (STA) reference based on Map of Evacuation Route, Reclamation District 341 Sherman Island by Wagner Bonsignore Consulting Civil Engineers, A Corporation dated July 2012, STA 778+00]						
FS Date: 5/6/2009

View of waterward side. Conduit goes through concrete structure connecting walkway.

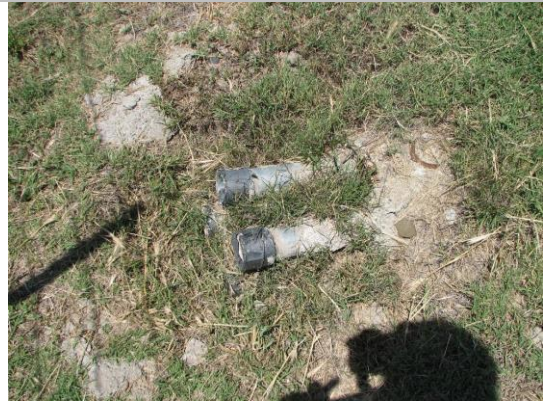
Photo 3 of 3 : UCIP_SP_2020_22303_38060.jpg

View of conduit on landward side. Four 2.5-inch conduits through levee not in use yet.

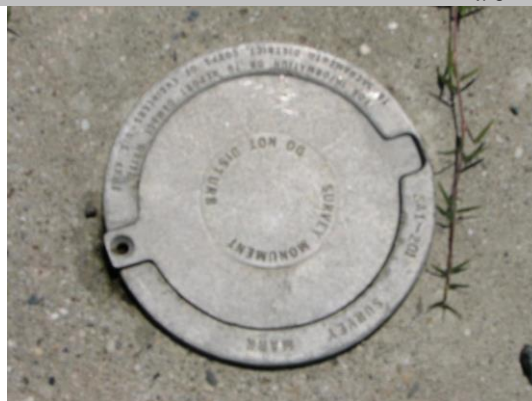
Photo 1 of 3 : UCIP_SP_2020_22306_38067.jpg

DS_ID:24130
FS_ID:22306
EP_NO: 3494
Repair Type: Non-Urgent
Crossing Status: Indicator Found
UCIP Comments: Need to contact owner to determine status of crossing. Need date of last inspection and confirmation that crossing is still in operable condition.
FIELD_STRUCT_DESC: 1 of 2: 26-inch concrete encased steel gas line through the levee, 5.1 feet below the crown. Concrete cutoff wall around pipe at center of levee. Location sign on waterward shoulder. Rock revetment on waterward slope. Contact number listed on marker out in the field 1-800-811-4111. (two 26-inch lines authorized under Permit No. 3494, 1961 - Pacific Gas and Electric Company [PG&E])
[Additional Reference(s): DWR Levee Log, 1992. [LMA encroachment station (STA) reference based on Map of Evacuation Route, Reclamation District 341 Sherman Island by Wagner Bonsignore Consulting Civil Engineers, A Corporation dated July 2012, STA 756+00]

Survey marker found at this location.

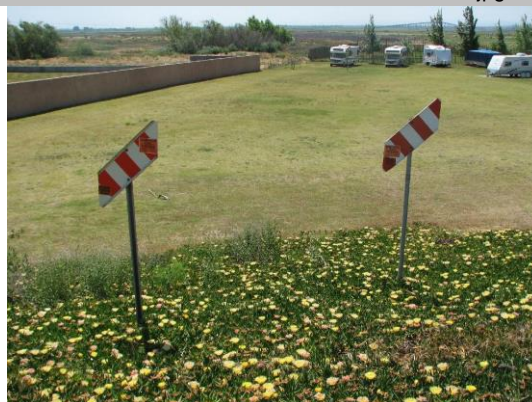
Photo 2 of 3 : UCIP_SP_2020_22306_38066.jpg

Gas line markers visible on landward side.

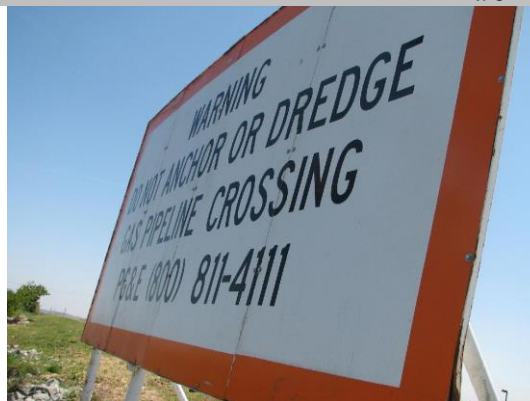
Photo 3 of 3 : UCIP_SP_2020_22306_38065.jpg

Gas line crossing sign located on waterward side.

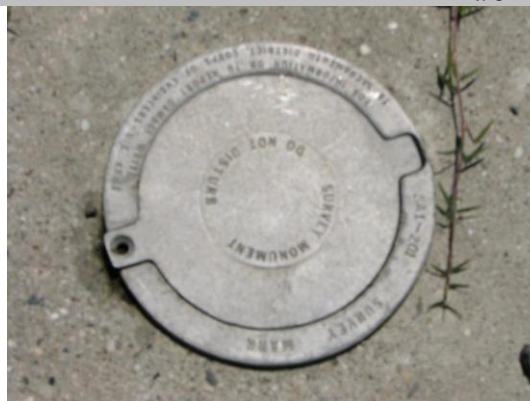
Photo 1 of 3 : UCIP_SP_2020_22307_38070.jpg

DS_ID:24233
FS_ID:22307
EP_NO: 3494
Repair Type: Non-Urgent
Crossing Status: Indicator Found
UCIP Comments: Need to contact owner to determine status of crossing. Need date of last inspection and confirmation that crossing is still in operable condition.
FIELD_STRUCT_DESC: 2 of 2: 26-inch concrete encased steel gas line through the levee, 5.1 feet below the crown. Concrete cutoff wall around pipe at center of levee. Location sign on waterward shoulder. Rock revetment on waterward slope. Contact number provided on marker out in the field 1-800-811-4111. (two 26-inch lines authorized under Permit No. 3494, 1961 - Pacific Gas and Electric Company [PG&E]) [Additional Reference(s): DWR Levee Log, 1992. LMA encroachment station (STA) reference based on Map of Evacuation Route, Reclamation District 341 Sherman Island by Wagner Bonsignore Consulting Civil Engineers, A Corporation dated July 2012, STA 756+00]

Surve marker or inclinometer located at site.

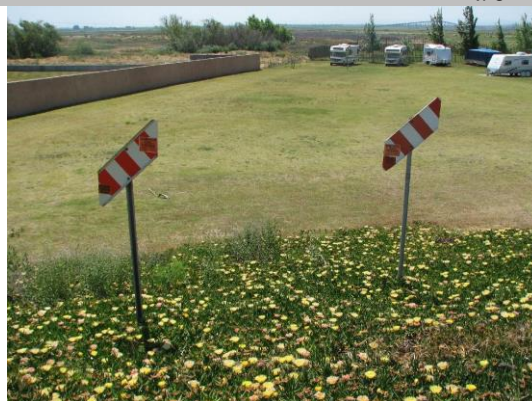
Photo 2 of 3 : UCIP_SP_2020_22307_38069.jpg

Gas line markers located on landward side.

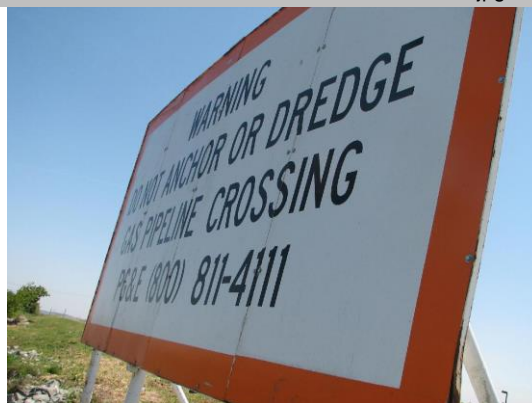
Photo 3 of 3 : UCIP_SP_2020_22307_38068.jpg

Gas line crossing sign located on waterward side.

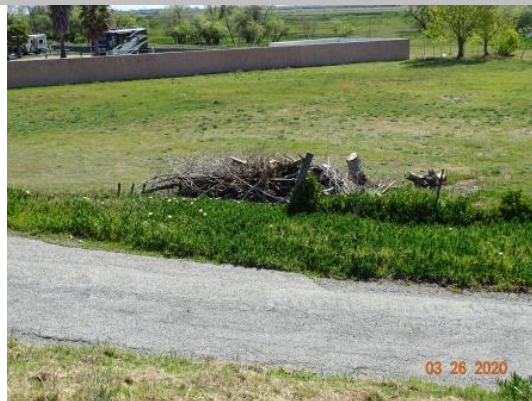
Photo 1 of 1 : SP_2020_RD0341_168_52_20200326_00090.jpg

View of pruning pile on the landside toe (Spring 2020).

LM Start	8.44	Rating **	M	Issue No.	52
LM End	8.44	Issue Type +	En	Location *	LS
Category	Earthen Levee			GPS Latitude/Longitude	
				Start	End
Item	Encroachments			38.070600 °	38.070600 °
				-121.766345 °	-121.766345 °
DWR ID	DWR_RD0341_02_s_2020_52				
Comment Code					
PR : Prunings					
Inspector Comment					
Remove pruning pile on the landside toe.

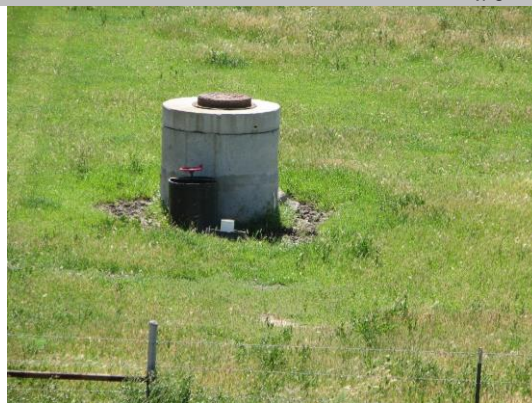
Photo 1 of 3 : UCIP_SP_2020_22309_38075.jpg

Comment Code					
Inspector Comment					
DS_ID:24247 FS_ID:22309 EP_NO: N/A Repair Type: Non-Urgent Crossing Status: Found UCIP Comments: 7/6/2016 Meet with Joel McElroy, District Representative, at site. DWR Bay Delta Division owns pipe. Pipe is active. Need to contact owner to determine permit authorizing pipe crossing. (DWR UCIP - O. Magana) 05/06/2009 New record found in the field. Unable to find any information for crossing during DWR desk study. Will need to find the owner and obtain records for crossing. Need to coordinate with CVFPB. (DWR UCIP - O. Magana) FIELD_STRUCT_DESC: 10-inch steel irrigation pipe through the levee, at a shallow depth below the crown. Air vent on the waterside (WS). Distribution box with slide gate and observation well on the landside (LS). Pumping station on the LS. Rip rap located on WS. [Additional Reference(s): LMA encroachment station (STA) reference based on Map of Evacuation Route, Reclamation District 341 Sherman Island by Wagner Bonsignore Consulting Civil Engineers, A Corporation dated July 2012, STA 751+00] FS Date: 5/6/2009

Concrete stand pipe and gate valve located on landward side.

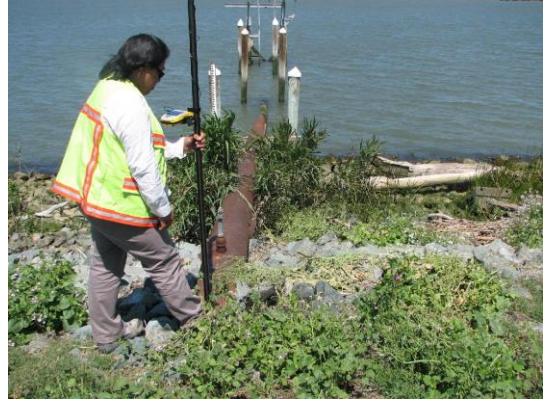
Photo 2 of 3 : UCIP_SP_2020_22309_38076.jpg

Overview of crossing on waterward side.

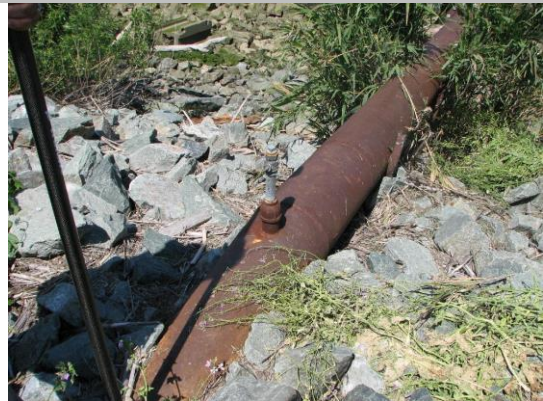
Photo 3 of 3 : UCIP_SP_2020_22309_38077.jpg

Siphon breaker visible on waterward side. Levee toe is armored with rock slope protection.

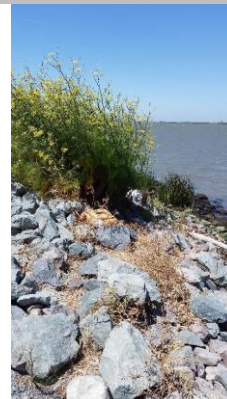
Photo 1 of 3 : UCIP_SP_2020_50082_75941.jpg

Comment Code					
Inspector Comment					
DS_ID:25470 FS_ID:50082 EP_NO: N/A Repair Type: Non-Urgent Crossing Status: Found UCIP Comments: 7/6/2016 Pipe found in 2009 has been removed and new pipe installed. Unable to determine permit authorizing work. Need to coordinate with owner to obtain details regarding permit and pipe install. (DWR UCIP - omagana) FIELD_STRUCT_DESC: UNK size pipe through the levee. (unknown permit authorizing work; previous 10-inch pipe removed between 2009-2016, 10-inch pipe authorized under Automatic Board Order (ABO) issued as Permit No. 11108, 1975 - D. Faria) [Additional Reference(s): LMA encroachment station (STA) reference based on Map of Evacuation Route, Reclamation District 341 Sherman Island by Wagner Bonsignore Consulting Civil Engineers, A Corporation dated July 2012, STA 743+00] FS Date: 7/6/2016

View of WS.

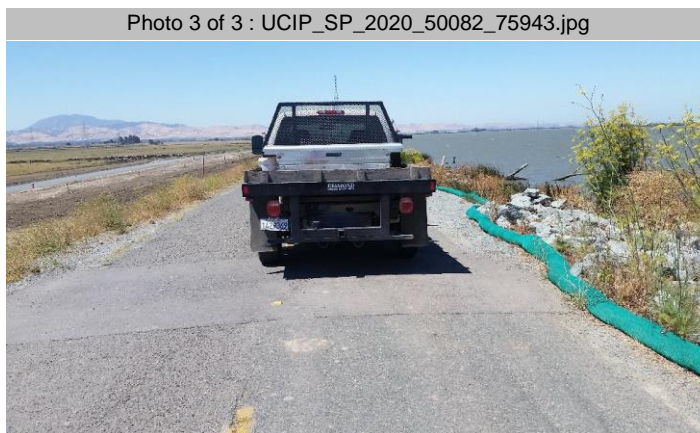
View of levee crown.

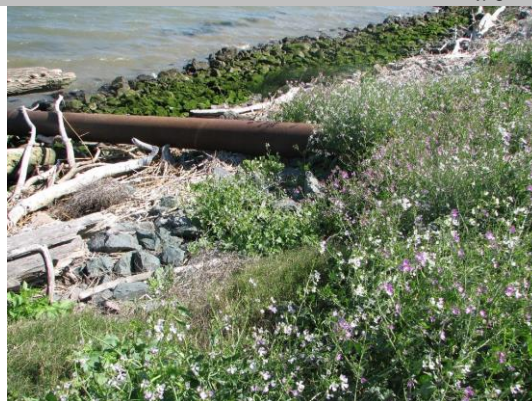
Photo 1 of 3 : UCIP_SP_2020_22324_38096.jpg

DS_ID:24133
FS_ID:22324
EP_NO: 11114
Repair Type: Non-Urgent
Crossing Status: Found
UCIP Comments: 7/6/2016 Meet with Joel McElroy, District Representative, at site. DWR Bay Delta Division owns pipe. Need to contact owner to determine status of pipe crossing. (DWR UCIP - O. Magana)
05/06/2009 Dense vegetation limits the inspector's visibility to identify signs of pipe failure (leaks) along the slope. Recommend removing vegetation along pipe alignment to conduct proper inspection of structure and appurtenances. (DWR UCIP - O. Magana)
FIELD_STRUCT_DESC: 14-inch steel pipe of unknown purpose through the levee, 4.0 feet below the levee crown. Concrete standpipe with slide gate located on the landside (LS). Rock revetment on the waterside (WS) slope. (14-inch pipe retained under Automatic Board Order (ABO) issued as Permit No. 11114, 1975 - E. J. Trigueiro)
[Additional Reference(s): DWR Levee Log, 1992. LMA encroachment station (STA) reference based on Map of Evacuation Route, Reclamation District 341 Sherman Island by Wagner Bonsignore Consulting Civil Engineers, A Corporation dated July 2012, STA 720+00]

Overview of waterward side.

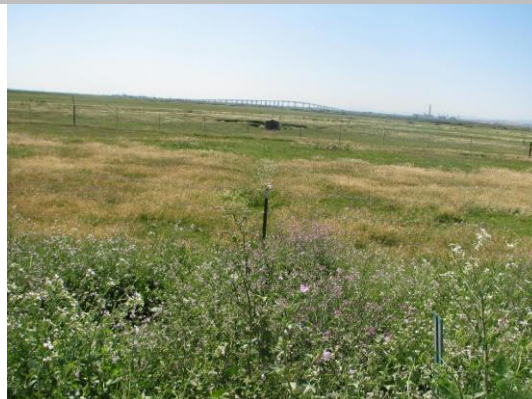
Photo 3 of 3 : UCIP_SP_2020_22324_38094.jpg

Overview of landward side.
